Contract #: 04-0120F4Cty: SF/ALA Rte: 80 PM: 13.2/13.9File #: 69.28**WELDING INSPECTION REPORT****Resident Engineer:**Pursell, Gary**Address:** 333 Burma Road**City:** Oakland, CA 94607**Report No:** WIR-003626**Date Inspected:** 28-Jul-2008**Project Name:** SAS Superstructure**OSM Arrival Time:** 2230**Prime Contractor:** American Bridge/Fluor Enterprises, a JV**OSM Departure Time:** 730**Contractor:** Zhenhua Port Machinery Company, Ltd (ZPMC), Changxing Island **Location:** Shanghai, China**CWI Name:** See below**CWI Present:** Yes No**Inspected CWI report:** Yes No N/A**Rod Oven in Use:** Yes No N/A**Electrode to specification:** Yes No N/A**Weld Procedures Followed:** Yes No N/A**Qualified Welders:** Yes No N/A**Verified Joint Fit-up:** Yes No N/A**Approved Drawings:** Yes No N/A**Approved WPS:** Yes No N/A**Delayed / Cancelled:** Yes No N/A**Bridge No:** 34-0006**Component:** OBG Fabrication**Summary of Items Observed:**

Tower Fabrication:

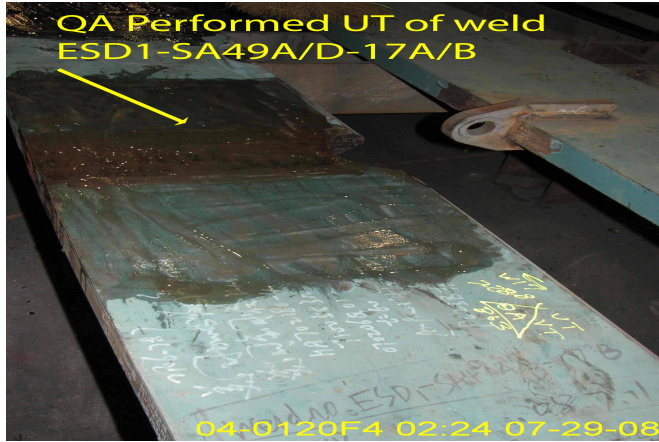
The QA Inspector completed Visual and Ultrasonic (UT) inspection of the entire length of welds ESD1-SA49A/D-13A/B, ESD1-SA49A/D-14A/B, ESD1-SA49A/D-17A/B, ESD1-SA49A/D-18A/B and ESD1-SA49C/D-3A/B to determine if they comply with AWS D1.5 requirements. ZPMC had previously accepted ultrasonic inspections of these welds. Items observed by the QA Inspector appear to comply with project specifications. See the TL6027 ultrasonic test report and the photograph below for additional information.
